STM32H742x/743xI/G, ST32H750xB and STM32H753xI device errata

It gives a summary and a description of the device errata, with respect to the device datasheet and reference manual RM0433.

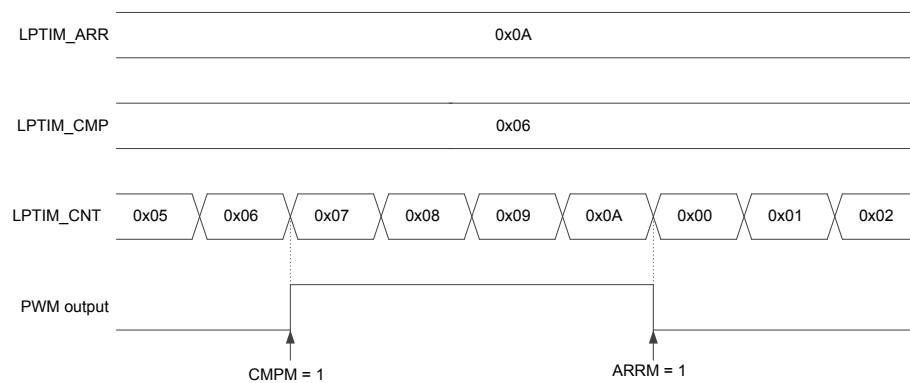
Consequently, it is not possible to generate PWM with a duty cycle of 0% or 100%.

The following waveform gives the example of PWM output mode and the effect of the delay:

Set the compare value to the desired value minus 1. For instance in order to generate a compare match when LPTM_CNT = 0x08, set the compare value to 0x07.

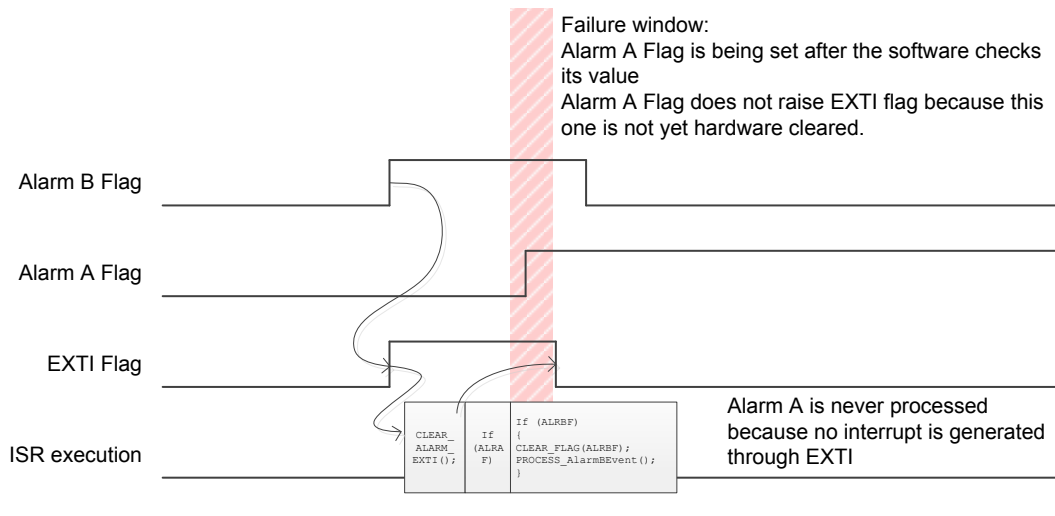
Figure 1. Masked RTC interrupt

The following code example and figure illustrate the failure mechanism: The Alarm A event is lost (fails to generate interrupt) as it occurs in the failure window, that is, after checking the Alarm A event flag but before the effective clear of the EXTI interrupt flag by hardware. The effective clear of the EXTI interrupt flag is delayed with respect to the software instruction to clear it.

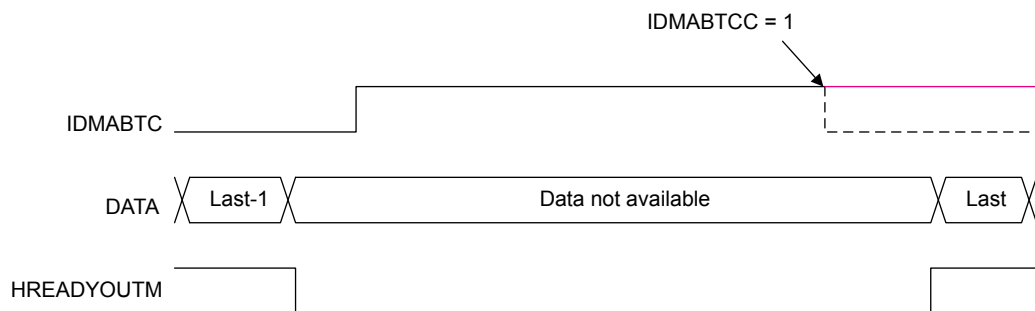
Figure 2. SDMMC AHB transfer vs IDMABTC flag status

If the internal/external memory is not ready to transmit/receive the last word before the IDMABTCC is set, the IDMABTC flag is not cleared whereas it should be (see Figure 2). As a result, the software may consider it several times.

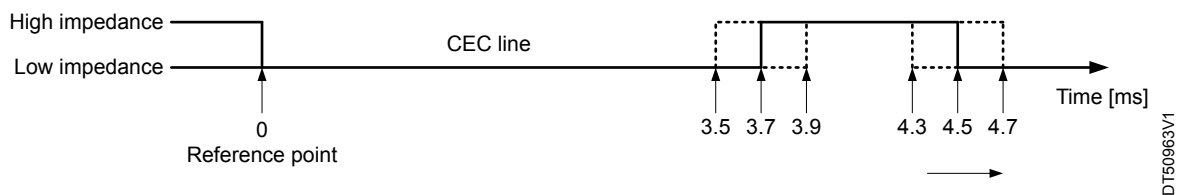
Figure 3. CEC start bit format with tolerances

If one of these conditions is not met, the transmission is aborted and never automatically retried. No error flag is set and the TXSOM (Tx Start Of Message) bit is not cleared.

The only way to detect this error is for the application software to start a timeout when setting the TXSOM bit, restart it upon ARBLST or any RX event (as the transmission can be delayed by interleaved reception), and stop it upon TXBR (proof that the start bit was transmitted successfully) or TXEND event, or upon any TX error (which clears TXSOM). If the timeout expires (because none of those events occurred), the application software must restart the CEC peripheral and retransmit the message.
