STM32H742x/743xI/G, ST32H750xB and STM32H753xI device errata

It gives a summary and a description of the device errata, with respect to the device datasheet and reference manual RM0433.

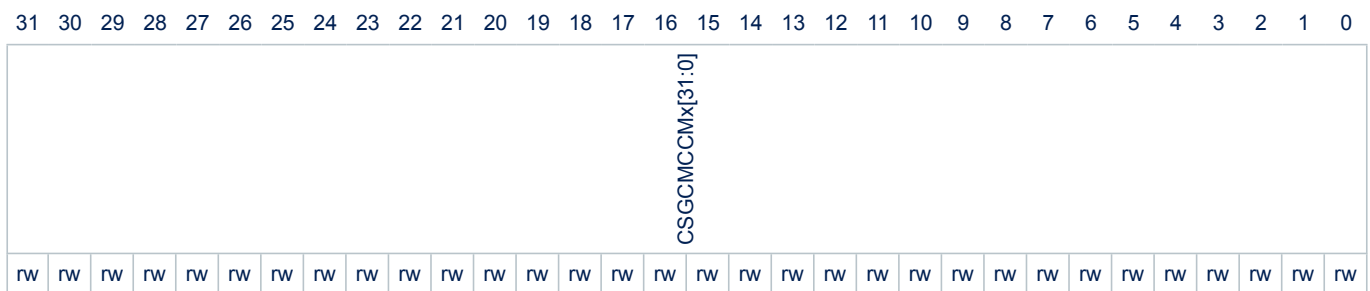
CRYP context swap GCM-CCM registers (CRYP_CSGCMCCMxR)

2.15.2 CRYP_CSGCMCCMxR registers are missing

In some reference manuals, the *CRYP context swap GCM-CCM registers (CRYP_CSGCMCCMxR)* section is missing in the *cryptographic processor (CRYP)* chapter. These registers, described next, are required to run the suspend/resume operations for the GCM and CCM chaining modes.
